AERIAL PHOTOGRAPHIC ANALYSIS OF THE CHEMETCO, INCORPORATED, FACILITY

Hartford, Illinois

J. S. Duggan Environmental Programs Lockheed Engineering and Management Services Company, Inc. Las Vegas, Nevada 89114

ENVIRONMENTAL MONITORING SYSTEMS LABORATORY OFFICE OF RESEARCH AND DEVELOPMENT U.S. ENVIRONMENTAL PROTECTION AGENCY LAS VEGAS, NEVADA 89114

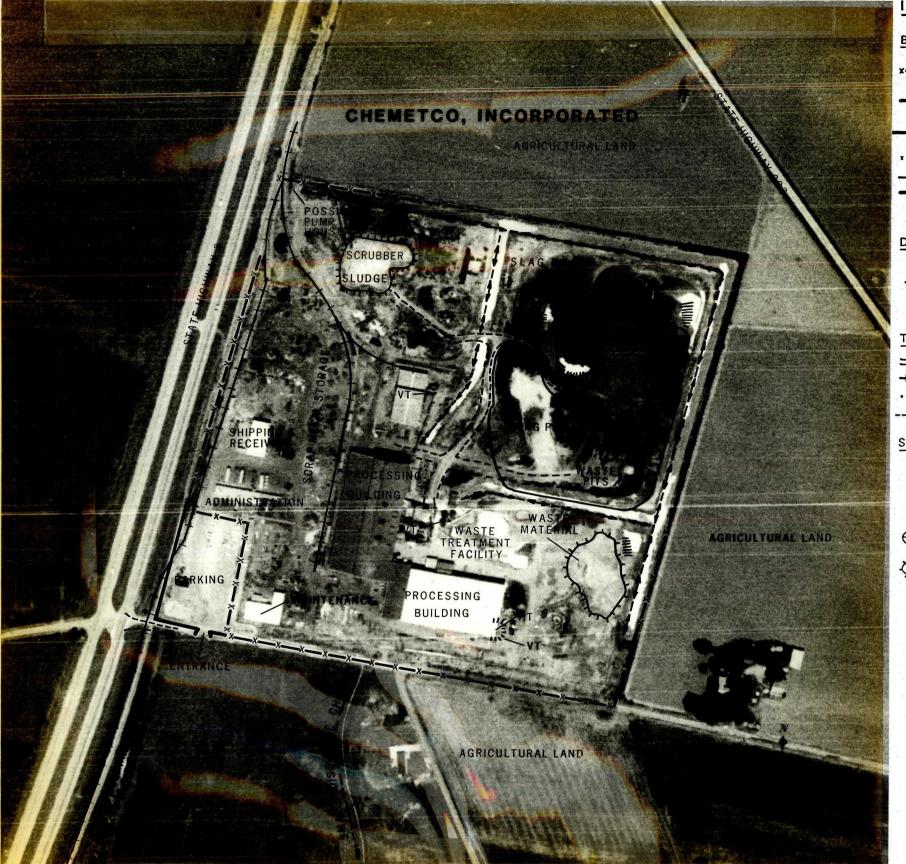
Figure 3. Chemetco, Inc., June 10, 1978. Approximate scale, 1 inch equals 275 feet.

The Chemetco facility, located two miles south of Hartford, Illinois, occupies about 40 acres adjacent to State Highway 3 and the Illinois Terminal Railroad. There are two rail spurs into the facility and a single road entrance along the south boundary. The predominate features of the site are the large slag piles, the processing buildings, a waste treatment area, two small mounds, and a 30-foot wide ditch. There are two small vertical tanks and one horizontal tank present. Only the horizontal tank appears contained.

There are three 40 by 95 foot waste pits near the center of the pile with the dumping point at the south end of the pit. A small 0.5-acre mound of possible scrubber sludge is located in the northwest corner of the site while a similar sized pile of probable waste material can be seen in the southeast corner.

A 30-foot wide ditch extends across the north boundary and along most of the east boundary. Two other ditches extend from the center of the site to the north and to the east. A possible pump house is present at the west end of the north ditch. The flow of liquid in the ditches cannot be determined as there are no indications such as slope or wave action. A portion of the liquid is very light in tone indicating the possible presence of contaminants. The total length of all the ditches is 3,535 feet.

A single small drainage channel is evident in a field south of the site which may be used for discharge of waste liquid from the site. This channel is connected to Long Lake.

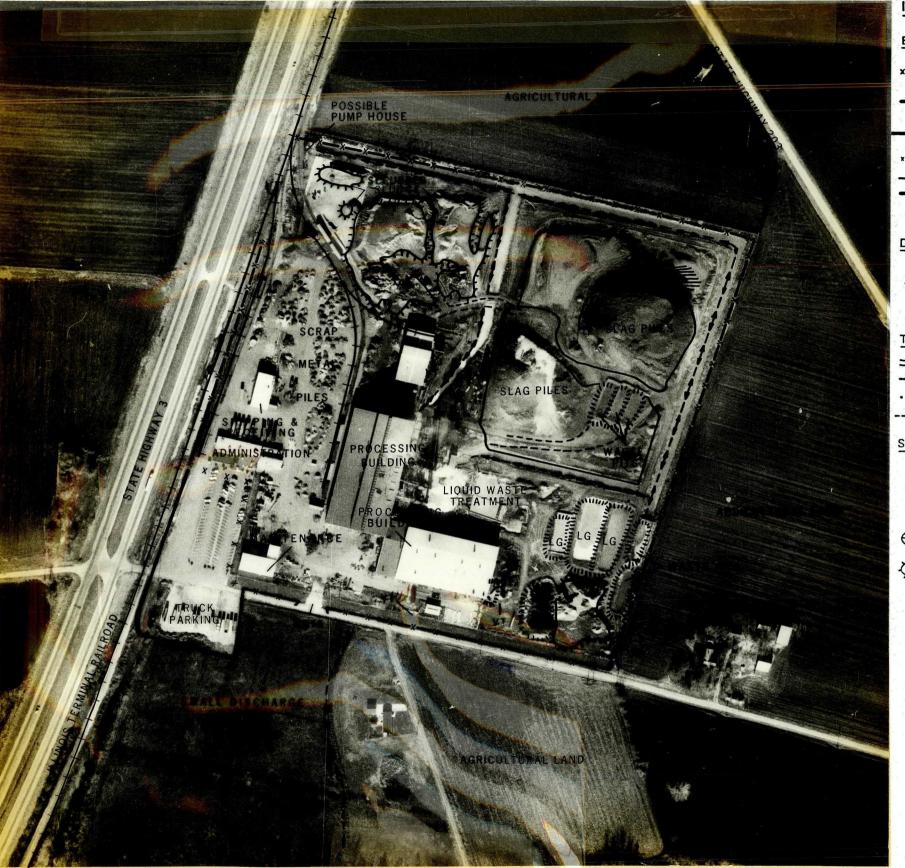
Figure 4. Chemetco, Inc., December 14, 1980. Approximate scale, 1 inch equals 275 feet.

WL WETLANDS Analysis of the 1980 photographs reveal only a very small increase in size in the site but some significant changes within the site. In the southwest corner across the road which is the south boundary of the site fill material has been brought in to create a truck parking area. This area is about one acre in extent so the facility now is about 41 acres.

Within the site the slag piles in the northeast corner are slightly larger and higher. The three waste pits are still present and appear to contain some waste material. The scrubber sludge pile in the northwest corner is much larger indicating continued processing activity at the site. In the southeast corner of the site three lagoons have been built. The largest of these is approximately 220 by 80 feet while the smallest is 110 by 55 feet. A portion of the adjacent ditch has been converted into two waste pits eliminating approximately 275 feet of the ditch. Both of these pits contain waste material. To the south of the lagoons there is a mound of material and an adjacent pool of liquid which is surrounded by a dike. A third vertical tank is present but does not appear to be contained.

The remainder of the site appears much as it did in 1978 with the exception of the prominent new entrance along the south boundary. The small discharge channel is still present but it is not possible to confirm if any liquid is present.

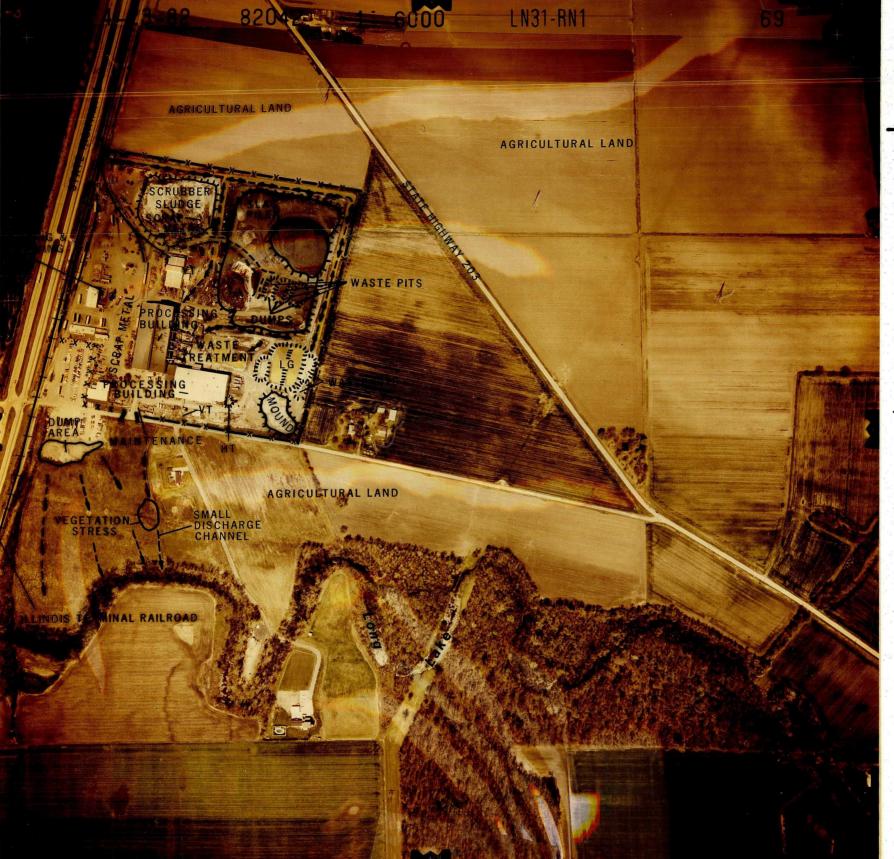
Figure 5. Chemetco, Inc., April 23, 1982. Approximate scale, 1 inch equals 500 feet.

Analysis of the color aerial photographs reveal several small changes in the overall appearance of the site. The slag piles have grown in size to about 8 acres while the scrubber sludge piles are about 2.6 acres. A fourth waste pit has been added in the slag pile area but it appears to be open at the north end.

The waste lagoons all contain liquid while the two adjacent waste pits appear full. The mound present in 1980 is slightly smaller in 1982 and the adjacent pool of liquid has either been removed or has been covered over. The shipping/receiving area, the processing buildings, waste treatment area, and the maintenance area remain the same as in 1980.

The area south of the main facility that was a parking lot area has been expanded by about 1 acre and appears to be used for dumping of waste material. Drainage from this dump area is south toward Long Lake. A small area (150 by 100 feet) adjacent to the discharge channel appears to have suffered some vegetation stress.

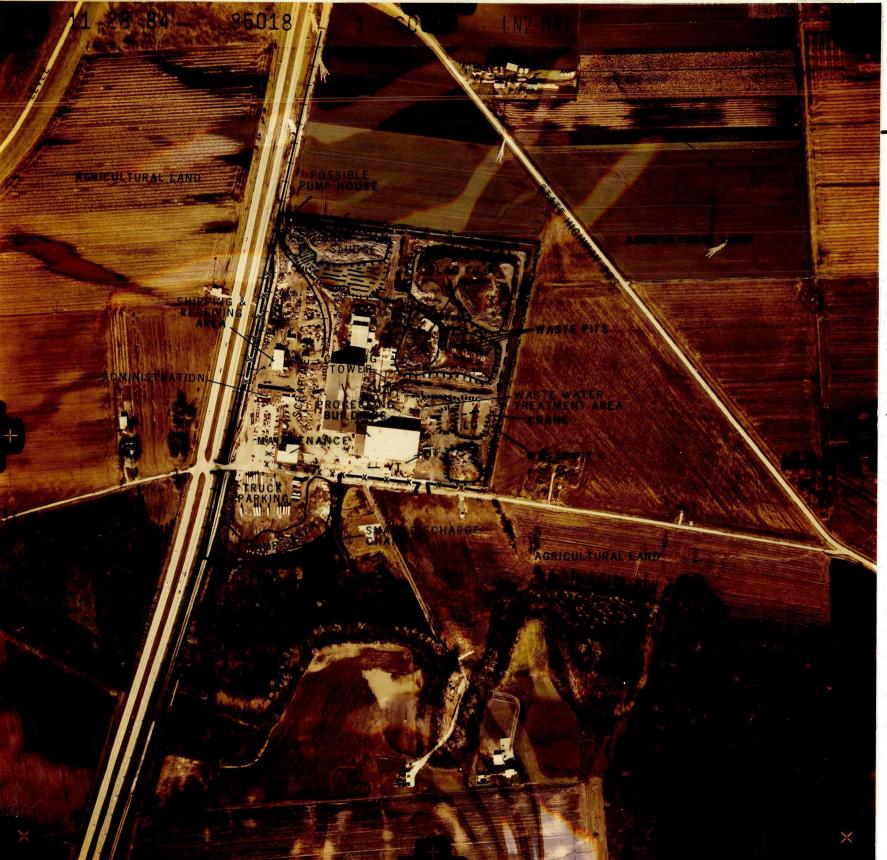
Figure 6. Chemetco, Inc., November 28, 1984. Approximate scale, 1 inch equals 500 feet.

The color aerial photographs of November 28, 1984, reveal continued activity at the Chemetco facility. There appears to be more scrap piles in the shipping and receiving area. The scrubber sludge piles have grown and two bodies of liquid are visible. These pools of liquid total about 1.35 acres. The slag piles remain much the same as in 1982 and there are still four waste pits within the piles.

In the southeast corner the large lagoon still contains liquid but the smaller lagoon now appears to be filled with solid material. The two waste pits east of the lagoons appear full but it appears from the presence of an excavation crane that one of the pits is being emptied. Near the center of the site adjacent to the processing building and the waste treatment area, there are two cooling towers constructed since the overflight of 1982.

The dump area to the south of the site has been expanded further out into the adjacent field. This adds another 3 acres to the site, increasing the overall site size to about 45 acres. The different tones of the material in the dump indicates a variety of wastes are present. Drainage from this area is toward the south and Long Lake.
